**Flood Control Project Maintenance
Levee Inspections**

Fall 2018 Levee Maintenance Deficiency Summary Report

Sacramento River Basin

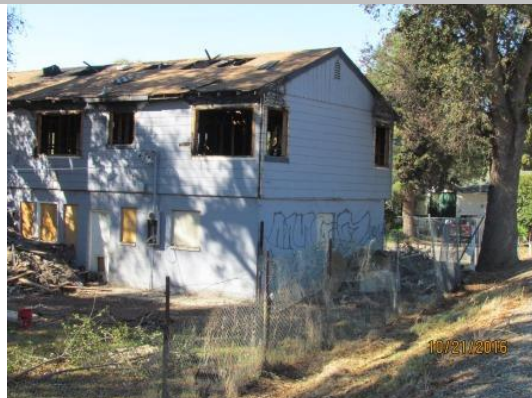
Photo 1 of 1 : FA_2018_NA0001_51_29_20180911_00023.jpg

LM Start	2.02	Rating **	U	Issue No.	29
LM End	2.02	Issue Type +	En	Location *	LS
Category	Earthen Levee			GPS Latitude/Longitude	
				Start	End
Item	Encroachments			38.627292°	38.627292°
				-121.433709°	-121.433709°
DWR ID	DWR_NA0001_01_s_2012_29				
Comment Code					
BU : Building					
Inspector Comment					
Two-story home foundation is within 10-ft of levee toe. Chain link fence is built on levee toe.

Building foundation is within 15' of the levee toe.

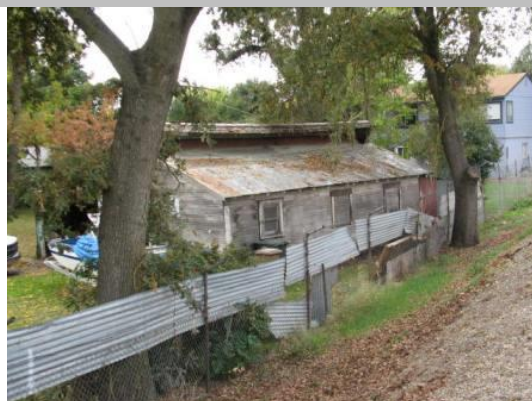
Photo 1 of 1 : FA_2018_NA0001_51_28_20180911_00022.jpg

LM Start	2.04	Rating **	U	Issue No.	28
LM End	2.04	Issue Type +	En	Location *	LS
Category	Earthen Levee			GPS Latitude/Longitude	
				Start	End
Item	Encroachments			38.627257 °	38.627257 °
				-121.433327 °	-121.433327 °
DWR ID	DWR_NA0001_01_s_2012_28				
Comment Code					
BU : Building					
Inspector Comment					
Large wooden building behind corrugated metal covered fence is within 10-ft of levee toe.

11/17/2011 Wooden structure is within 15' of the levee toe.

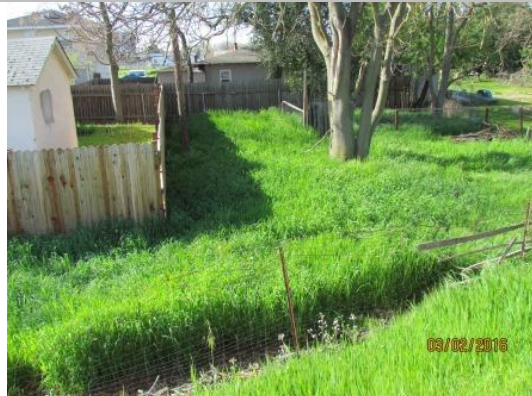
Photo 1 of 1 : FA_2018_NA0001_51_51_20180911_00033.jpg

LM Start	2.06	Rating **	M	Issue No.	51
LM End	2.06	Issue Type +	En	Location *	LS
Category	Earthen Levee			GPS Latitude/Longitude	
				Start	End
Item	Encroachments			38.627251 °	38.627251 °
				-121.432843 °	-121.432843 °
DWR ID	DWR_NA0001_01_f_2015_51				
Comment Code					
FE : Fence					
Inspector Comment					
Fence at landside levee toe.

View of the fence at the landside levee toe.

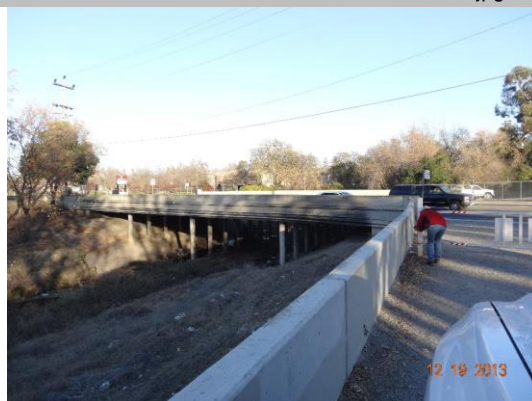
Photo 1 of 3 : UCIP_FA_2018_31185_57091.jpg

LM Start	2.08	Rating **	M	Issue No.	193
LM End	2.08	Issue Type +	En	Location *	
Category	Supplemental			GPS Latitude/Longitude	
				Start	End
Item	DWR UCIP Field Study			38.627239 °	38.627239 °
				-121.432501 °	-121.432501 °
DWR ID	24420				
Comment Code					
Inspector Comment					
FS_ID:31185 DS_ID:24420 EP_NO: 13044 Repair Type: Non-Urgent Crossing Status: Indicator Found UCIP Comments: Orange/Green symbol for flood structure found on floodwall. No crossing found. Need to determine if crossing is in use. This crossing is not shown in the City of Sacramento's sewer drain mains or water mains. Need to contact owner to determine if crossing is still in use. FIELD_STRUCT_DESC: 12-inch steel water main through the levee, 4 feet below the crown. (12-inch pipe authorized under Permit No. 13044, 1981-City of Sacramento) FS Date: 12/19/2013

Overview markers located on bridge and floodwall indicating crossing through levee.

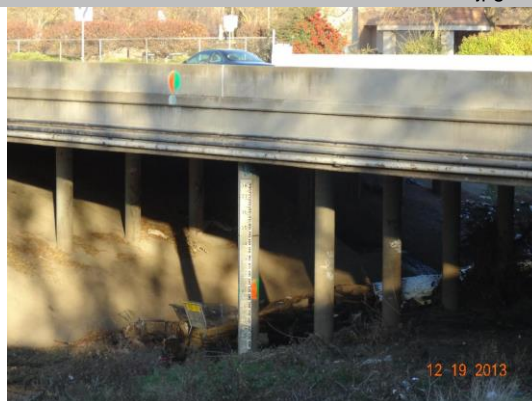
Photo 2 of 3 : UCIP_FA_2018_31185_57090.jpg

Markers visible of crossing on bridge.

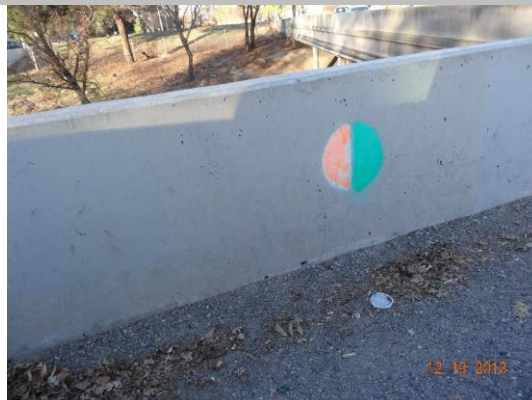
Photo 3 of 3 : UCIP_FA_2018_31185_57089.jpg

Marker of crossing on floodwall indicating crossing through levee.

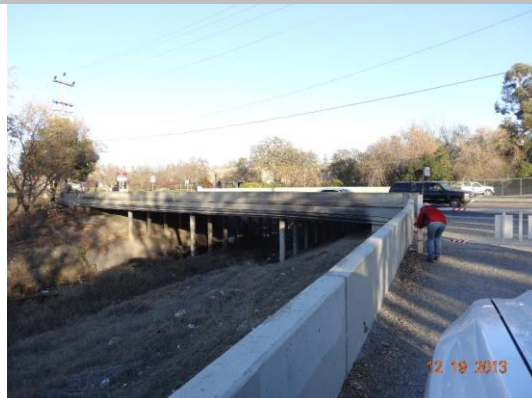
Photo 1 of 2 : UCIP_FA_2018_31424_57481.jpg

LM Start	2.08	Rating **	M	Issue No.	194	
LM End	2.08	Issue Type +	En	Location *		
Category	Supplemental			GPS Latitude/Longitude		
				Start	End	
Item	DWR UCIP Field Study			38.627242 °	38.627242 °	
				-121.432469 °	-121.432469 °	
DWR ID	24797					
Comment Code						
Inspector Comment						
FS_ID:31424						
DS_ID:24797						
EP_NO: N/A						
Repair Type: Non-Urgent						
Crossing Status: Found						
UCIP Comments: no permit--need to determine additional information and owner of crossings.						
FIELD_STRUCT_DESC: one 4-inch conduit and one 2-inch communication cable through levee at an unknown depth below the crown. Conduits are suspended through waterway and attached to downstream face of bridge.						
FS Date: 12/19/2013

View of waterward side--conduits visible on bridge face.

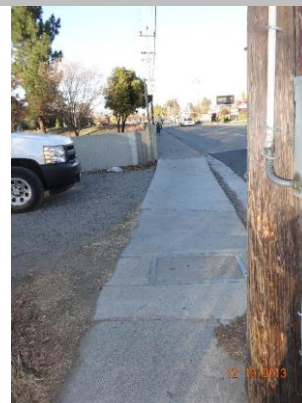
Photo 2 of 2 : UCIP_FA_2018_31424_57480.jpg

Service box located on sidewalk unable to determine if box belongs to conduits.

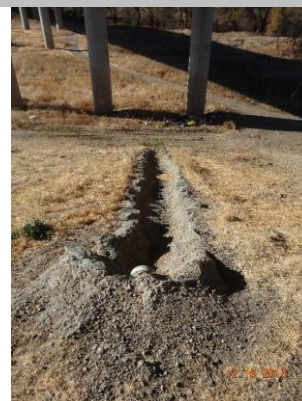
Photo 1 of 3 : UCIP_FA_2018_31443_57484.jpg

Comment Code						
Inspector Comment						
FS_ID:31443 DS_ID:24798 EP_NO: N/A Repair Type: Non-Urgent Crossing Status: Indicator Found UCIP Comments: 08/16/2017 DWR Deferred Maintenance Project (DMP), Vince Rodriguez, forwarded email received from Tim Kerr, General Manager of American River Flood Control District (ARFCD) with file "DWR Eligible Pipes Found in ARFCD" from ARFCD that shows the ownership and location of the pipes Tim Kerr investigated. No owner was identified, ARFCD Staff Notes indicate 4-inch HDPE under Arden-Garden Connector. (DWR UCIP - O. Magana) 12/06/2013 no permit (unauthorize crossing)--need to determine additional information about crossing. Unable to determine if pipe crosses levee. (DWR UCIP - O. Magana) FIELD_STRUCT_DESC: 4-inch high density polyethylene (HDPE) pipe through levee at unknown depth. (no permit has been identified authorizing this crossing, owner has not been identified) FS Date: 12/6/2013

View of waterward slope.

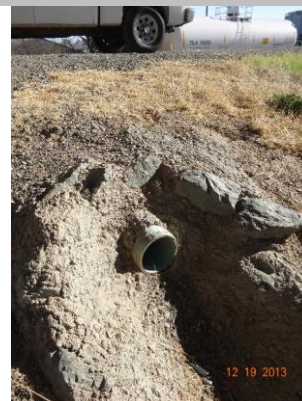
Photo 2 of 3 : UCIP_FA_2018_31443_57483.jpg

View of pipe through levee.

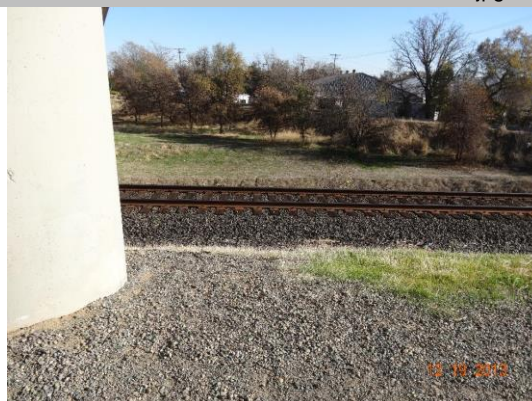
Photo 3 of 3 : UCIP_FA_2018_31443_57482.jpg

Comment Code						
Inspector Comment						
FS_ID:31443 DS_ID:24798 EP_NO: N/A Repair Type: Non-Urgent Crossing Status: Indicator Found UCIP Comments: 08/16/2017 DWR Deferred Maintenance Project (DMP), Vince Rodriguez, forwarded email received from Tim Kerr, General Manager of American River Flood Control District (ARFCD) with file "DWR Eligible Pipes Found in ARFCD" from ARFCD that shows the ownership and location of the pipes Tim Kerr investigated. No owner was identified, ARFCD Staff Notes indicate 4-inch HDPE under Arden-Garden Connector. (DWR UCIP - O. Magana) 12/06/2013 no permit (unauthorize crossing)--need to determine additional information about crossing. Unable to determine if pipe crosses levee. (DWR UCIP - O. Magana) FIELD_STRUCT_DESC: 4-inch high density polyethylene (HDPE) pipe through levee at unknown depth. (no permit has been identified authorizing this crossing, owner has not been identified) FS Date: 12/6/2013

View of landward side.

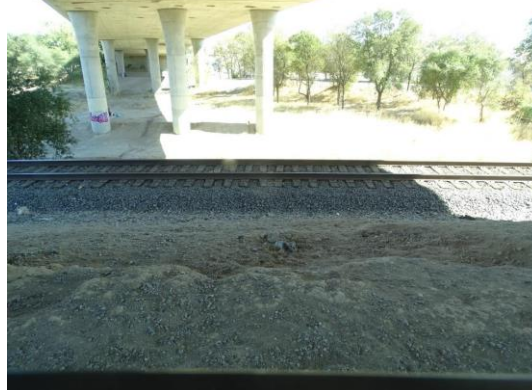
Photo 1 of 1 : FA_2018_NA0001_52_21_20181015_00055.jpg

LM Start	0.37	Rating **	M	Issue No.	21
LM End	0.37	Issue Type +	Ma	Location *	LS
Category	Earthen Levee			GPS Latitude/Longitude	
				Start	End
Item	Slope Stability			38.606430°	38.606430°
				-121.467782°	-121.467782°
DWR ID	DWR_NA0001_02_f_2018_21				
Comment Code					
S1 : Repair slope instability.					
Inspector Comment					
Repair slope damage.

View of slope damage on levee slope. Fall 2018

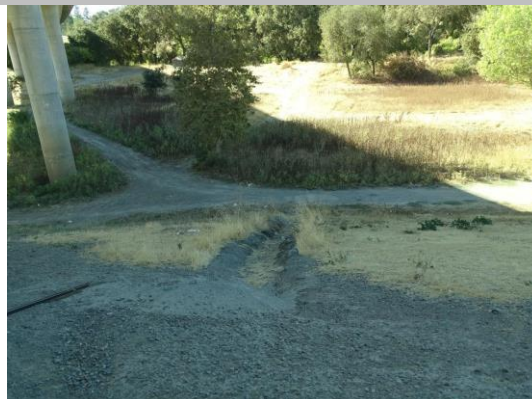
Photo 1 of 1 : FA_2018_NA0001_52_43_20181015_00059.jpg

LM Start	0.37	Rating **	M	Issue No.	43
LM End	0.37	Issue Type +	Ma	Location *	WS
Category	Earthen Levee			GPS Latitude/Longitude	
				Start	End
Item	Slope Stability			38.606435°	38.606435°
				-121.467772°	-121.467772°
DWR ID	DWR_NA0001_02_f_2018_43				
Comment Code					
S2 : Repair the levee slope damaged by foot traffic and prevent access where possible.					
Inspector Comment					
Repair slope damage from footpath dug into slope.

View of footpath dug into levee slope and lined with rocks. Fall 2018

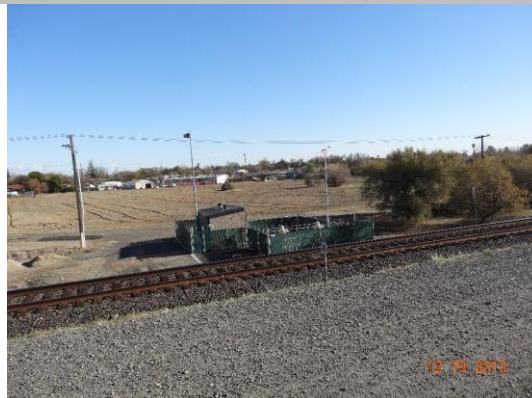
Photo 1 of 3 : UCIP_FA_2018_49533_55042.jpg

UCIP Comments: 08/29/2016 Facility details confirmed by the City of Sacramento only one 36-inch WSP goes through levee at this location. Ownership in the CVFPB records still shows ARFCD. Efforts to update CVFPB records are in-progress, owner of this facility is the City of Sacramento. Need to coordinate with ARFCD and City of Sacramento to determine the fate of Pump Station 3. (DWR UCIP - Olivia M)12/19/2013 Need to determine the status of crossing. Unable to confirm if crossing found in field corresponds to this entry.

View of landward side--pump station with multiple pumps.

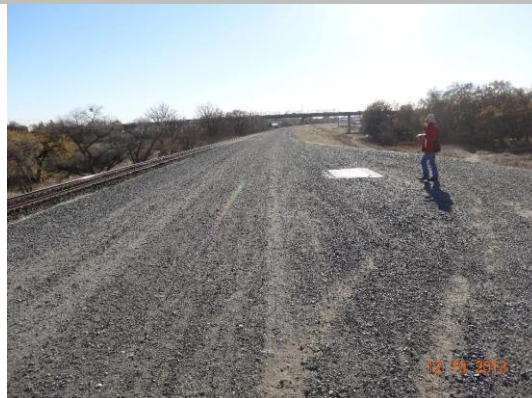
Photo 2 of 3 : UCIP_FA_2018_49533_55041.jpg

Vault located on levee crown.

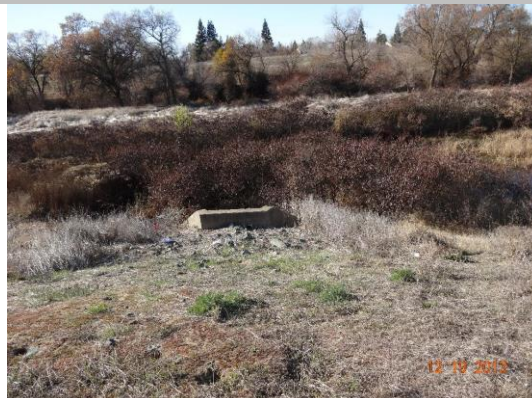
Photo 3 of 3 : UCIP_FA_2018_49533_55040.jpg

Concrete headwall visible on waterward side.

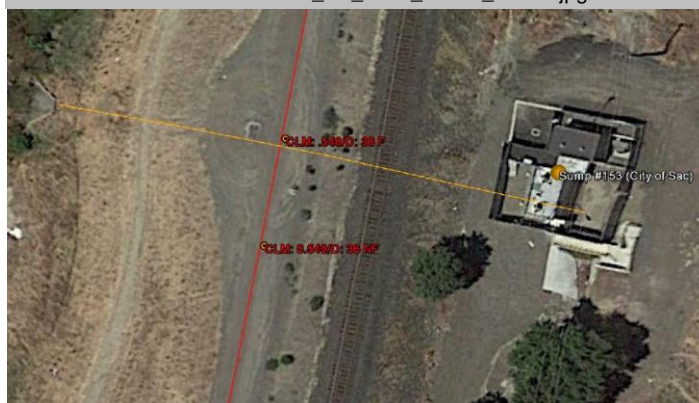
Photo 1 of 2 : UCIP_FA_2018_51428_75580.jpg

UCIP Comments: 08/29/2016 Facility details confirmed by the City of Sacramento. This crossing was an existing pipe that was mentioned in Permit No. 6064 and 6064-A under the following conditions: Thirteen: "that the existing 36-inch diameter corrugated metal pipe shall be allowed to remain in place for a period of 10 years, (until May 1978), at which time if the old pumping plant has not been used the pipe through the levee shall be removed by the applicant." and Fifteen: "That the existing 36-inch pipe shall be properly capped or sealed on both ends. Need to coordinate with the City of Sacramento and ARFCD to determine the fate of this crossing. Application No. 6064 references U.S. Corps of Engineers Stat. 217+00 as Pump Plant No. 3. (DWR UCIP - O. Magana)12/19/2013 Multiple pumps visible on landward side however unable to confirm additional crossings. Only 1 crossing was found at this location. (DWR UCIP - O. Magana)

Approx. location of USACE O&M original 36-inch located 40 feet downstream from Sump 153.

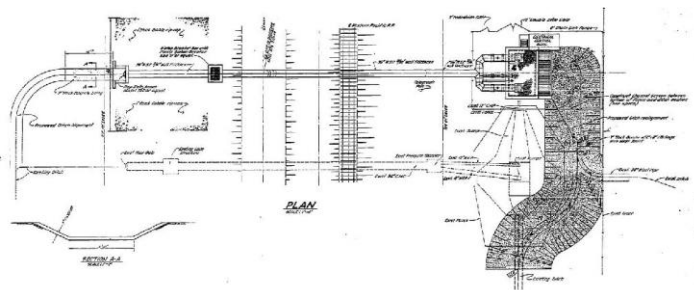
Photo 2 of 2 : UCIP_FA_2018_51428_75578.jpg

Sump 153 Plan and Profile, existing Pump Plant No. 3 referenced.

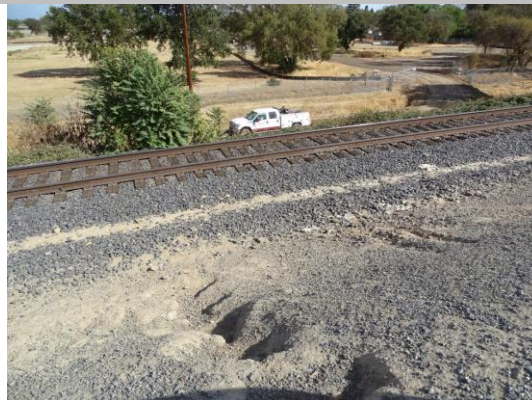
Photo 1 of 1 : FA_2018_NA0001_52_41_20181015_00052.jpg

LM Start	0.92	Rating **	M	Issue No.	41
LM End	0.92	Issue Type +	Ma	Location *	LS
Category	Earthen Levee			GPS Latitude/Longitude	
				Start	End
Item	Slope Stability			38.614240 °	38.614240 °
				-121.466645 °	-121.466645 °
DWR ID	DWR_NA0001_02_f_2018_41				
Comment Code					
S2 : Repair the levee slope damaged by foot traffic and prevent access where possible.					
Inspector Comment					
Repair slope damage from footpath dug into levee.

View of steps dug into levee slope. Fall 2018

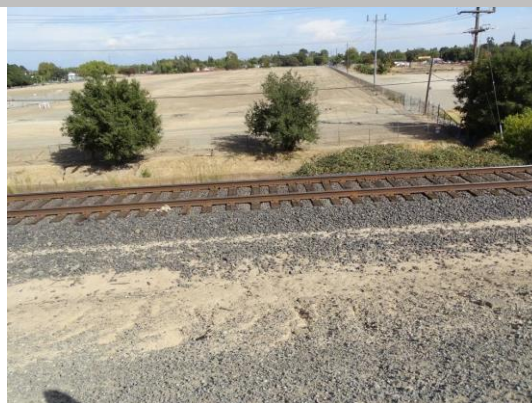
Photo 1 of 1 : FA_2018_NA0001_52_40_20181015_00051.jpg

LM Start	0.99	Rating **	A/W	Issue No.	40
LM End	0.99	Issue Type +	Ma	Location *	LS
Category	Earthen Levee			GPS Latitude/Longitude	
				Start	End
Item	Erosion / Bank Caving			38.615296 °	38.615296 °
				-121.466856 °	-121.466856 °
DWR ID	DWR_NA0001_02_f_2018_40				
Comment Code					
E1 : Note and monitor erosion site.					
Inspector Comment					
Monitor erosion rills on slope.

View of erosion rills on slope. Fall 2018

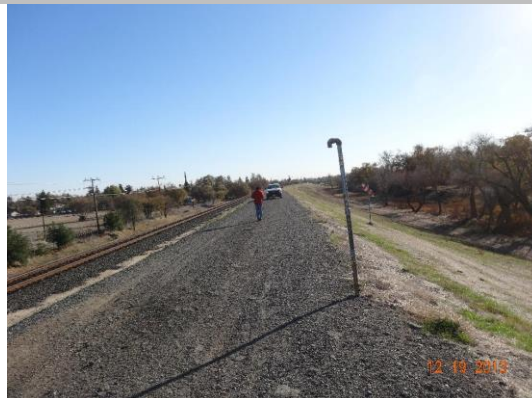
Photo 1 of 3 : UCIP_FA_2018_52673_55451.jpg

Comment Code					
Inspector Comment					
FS_ID:52673 DS_ID:24613 EP_NO: 2347 Repair Type: Non-Urgent Crossing Status: Indicator Found UCIP Comments: 08/11/2017 PG&E records for DFDS 3561 indicate that there were no observations found on the 07/2017 patrol, no leaks found on the 04/2017 leak survey, and the pipeline is operating correctly according to the 06/2017 CP inspection. (DWR UCIP - A. McDonald)11/3/2014 Need to contact owner to determine status of crossing. Priority under Part IX has been changed from Urgent to Non-Urgent as a measure to normalize the data. Markers present, however, unable to confirm pipe size. Recommend LMA to contact owner to determine additional information details--confirm pipe size, alignment, and last inspection completed confirming integrity of crossing. (DWR UCIP - O. Magana) 12/19/2013 Need to contact owner to determine status of crossing. Unable to confirm if indicators visible on levee crown and landward side correspond to this crossing. (DWR UCIP - O. Magana) FIELD_STRUCT_DESC: 6-inch gas line of unknown material through the levee, 2.5 feet below the crown. In case of an emergency related to this pipeline, PG&E has identified the following contacts: PG&E's local pipeline engineer, Mike Aronoff at 916-307-9472 (cell), and Gas Control (north) at 800-442-4743. For non-emergency issues, please contact the local PG&E Gas Pipeline Operations and Maintenance (GPOM) supervisors for the Sacramento region, David Wade at 209-639-1039 (cell), or Ron Hicks at 916-396-9038 (cell). (6-inch line authorized under Permit No. 2347, 1957 - Pacific Gas and Electric Company [PG&E]) [Additional Reference(s): DWR Levee Log, 2002] FS Date: 12/19/2013

Overview of levee crown with utility gas markers on waterward side.

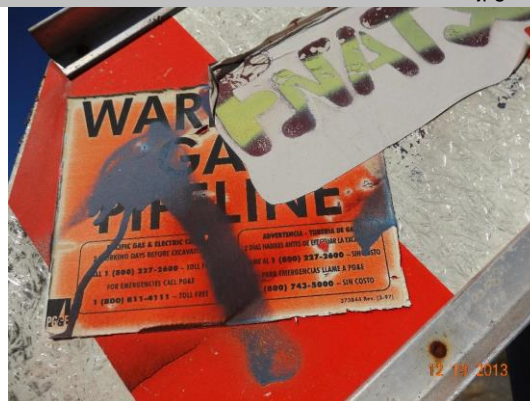
Photo 2 of 3 : UCIP_FA_2018_52673_55453.jpg

Contact information for owner--sign visible on waterward side slope.

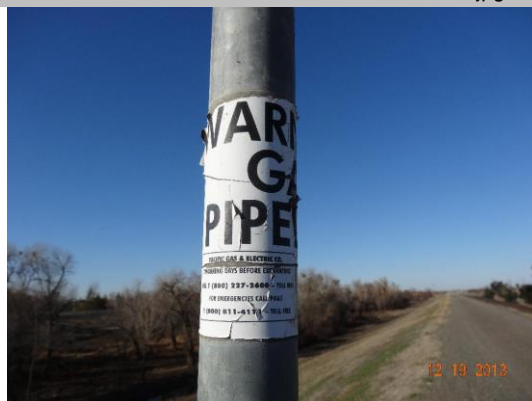
Photo 3 of 3 : UCIP_FA_2018_52673_55452.jpg

Multiple markers visible on waterward side--post with contact information.

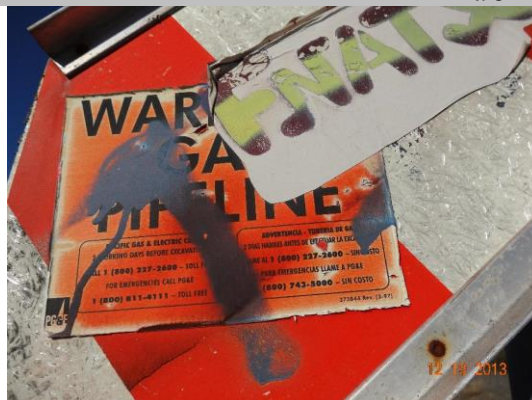
Photo 2 of 3 : UCIP_FA_2018_52679_52768.jpg

Marker with emergency contact information located on waterward slope.

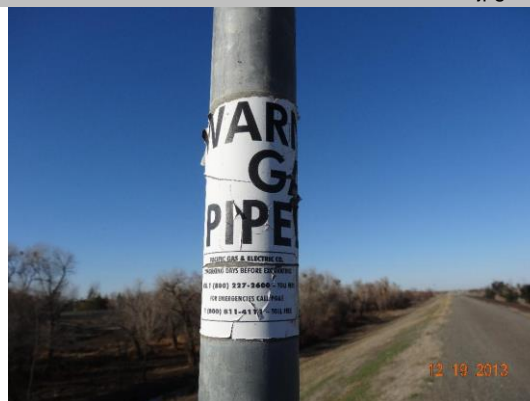
Photo 3 of 3 : UCIP_FA_2018_52679_52767.jpg

Marker located on the waterward side.

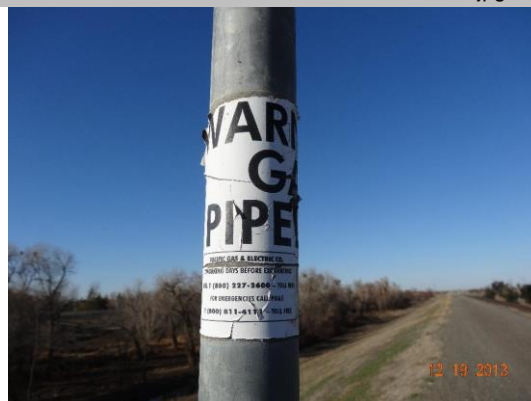
Photo 3 of 3 : UCIP_FA_2018_52682_52779.jpg

Comment Code						
Inspector Comment						
FS_ID:52682 DS_ID:24614 EP_NO: 1450 Repair Type: Non-Urgent Crossing Status: Indicator Found UCIP Comments: Need to contact owner to determine if pipe was left inside levee as part of abandonment process. FIELD_STRUCT_DESC: *ABANDONED* 12-inch steel gas line through the levee, 3 feet below the crown. Concrete cutoff wall around pipe under center of levee. Abandoned by grouting in 2002. In case of an emergency related to this pipeline, PG&E has identified the following contacts: PG&E's local pipeline engineer, Mike Aronoff at 916-307-9472 (cell), and Gas Control (north) at 800-442-4743. For non-emergency issues, please contact the local PG&E Gas Pipeline Operations and Maintenance (GPOM) supervisors for the Sacramento region, David Wade at 209-639-1039 (cell), or Ron Hicks at 916-396-9038 (cell). (12-inch pipe abandoned under Permit No. 17468, 2004 - Pacific Gas and Electric Company [PG&E]; 12-inch line authorized under Permit No. 1450, 1949 - PG&E) [Additional Reference(s): DWR Levee Log, 2002. USACE Sacramento O&M Manual Unit 118, Part No. 2, October 1959, (Station 243+31)] FS Date: 12/19/2013

Marker located on the waterward side.

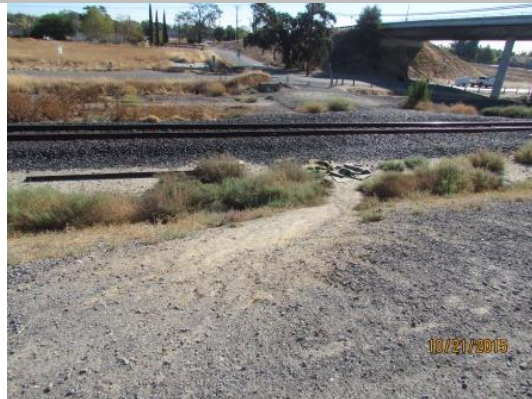
Photo 1 of 1 : FA_2018_NA0001_52_25_20180911_00007.jpg

LM Start	2.05	Rating **	M	Issue No.	25
LM End	2.05	Issue Type +	Ma	Location *	LS
Category	Earthen Levee			GPS Latitude/Longitude	
				Start	End
Item	Slope Stability			38.630425 °	38.630425 °
				-121.469807 °	-121.469807 °
DWR ID	DWR_NA0001_02_f_2015_25				
Comment Code					
S2 : Repair the levee slope damaged by foot traffic and prevent access where possible.					
Inspector Comment

View of the landside levee slope damaged by foot traffic.

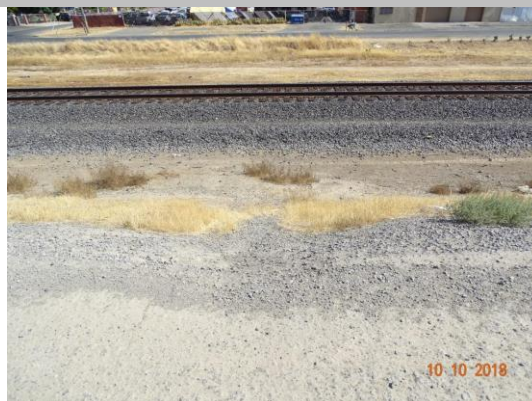
Photo 1 of 1 : FA_2018_NA0001_52_31_20181015_00049.jpg

LM Start	2.22	Rating **	A/W	Issue No.	31
LM End	2.22	Issue Type +	Ma	Location *	LS
Category	Earthen Levee			GPS Latitude/Longitude	
				Start	End
Item	Slope Stability			38.632841 °	38.632841 °
				-121.470258 °	-121.470258 °
DWR ID	DWR_NA0001_02_f_2018_31				
Comment Code					
S1 : Repair slope instability.					
Inspector Comment					
Monitor slope damage.

View of slope damage possibly from foot traffic. Fall 2018

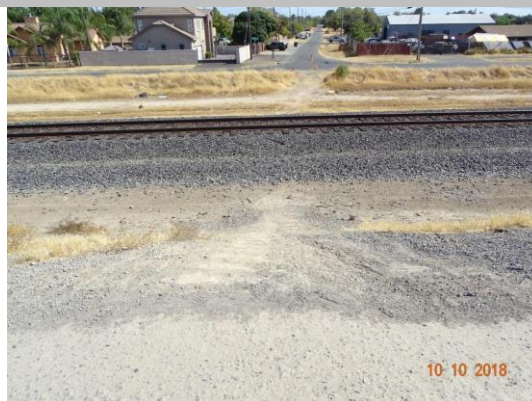
Photo 1 of 1 : FA_2018_NA0001_52_30_20181015_00048.jpg

LM Start	2.25	Rating **	A/W	Issue No.	30
LM End	2.25	Issue Type +	Ma	Location *	LS
Category	Earthen Levee			GPS Latitude/Longitude	
				Start	End
Item	Slope Stability			38.633308 °	38.633308 °
				-121.470349 °	-121.470349 °
DWR ID	DWR_NA0001_02_f_2018_30				
Comment Code					
S2 : Repair the levee slope damaged by foot traffic and prevent access where possible.					
Inspector Comment					
Monitor steps dug into levee slope.

View of stairs steps dug into levee slope. Fall 2018

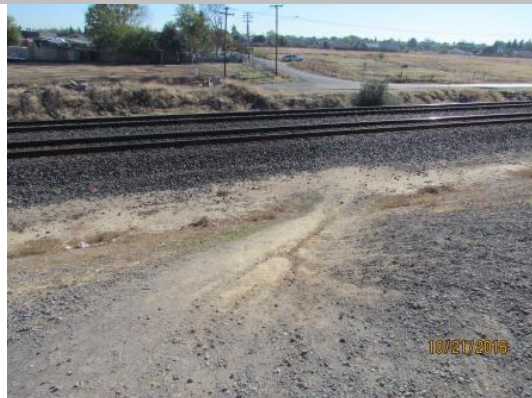
Photo 1 of 1 : FA_2018_NA0001_52_27_20180911_00009.jpg

LM Start	2.59	Rating **	M	Issue No.	27
LM End	2.59	Issue Type +	Ma	Location *	LS
Category	Earthen Levee			GPS Latitude/Longitude	
				Start	End
Item	Slope Stability			38.638109°	38.638109°
				-121.471254°	-121.471254°
DWR ID	DWR_NA0001_02_f_2016_27				
Comment Code					
S2 : Repair the levee slope damaged by foot traffic and prevent access where possible.					
Inspector Comment

View of the foot path on the landside levee slope. Fall 2016

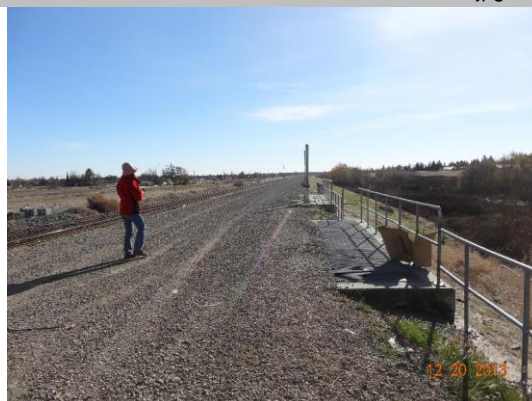
Photo 1 of 3 : UCIP_FA_2018_49862_52893.jpg

Overview of levee crown.

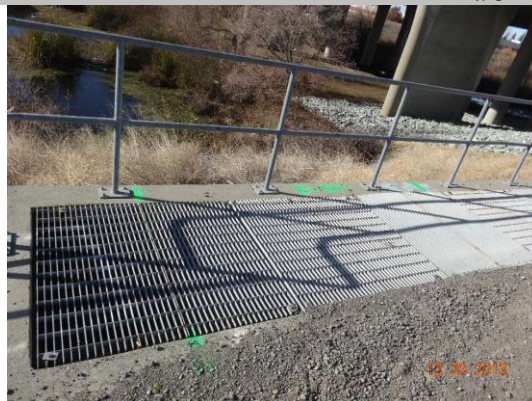
Photo 2 of 3 : UCIP_FA_2018_49862_52891.jpg

Concrete box contains 3-54 inch crossings.

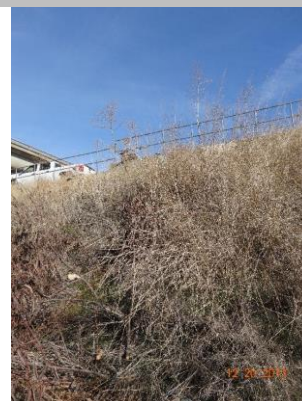
Photo 3 of 3 : UCIP_FA_2018_49862_52894.jpg

Comment Code						
Inspector Comment						
FS_ID:49862						
DS_ID:24608						
EP_NO: 9596						
Repair Type: Non-Urgent						
Crossing Status: Indicator Found						
UCIP Comments: Dense vegetation on waterward side limits inspector's inspection. Recommend removing vegetation.						
FIELD_STRUCT_DESC: [Sump No. 157] 1 of 3: 54-inch steel drainage pipe through the levee, 3 feet below the crown. Steel cutoff wall around pipe under center of levee. Siphon breaker in protective housing located on the waterside (WS) shoulder. Concrete headwall and flap gate located on the WS end. Trench on WS. Pumping plant located on the landside (LS). On March 28, 1995, the Sacramento City Council adopted Resolution No. 95-123 authorizing the execution of Agreement No. 95-065 regarding the transfer of drainage facilities that include Pump Station 7 as described by ARFCD and described by the City of Sacramento as Sump 157. (three 54-inch pipes installed in the siphon breaker structure but only one pipe installed through levee under Permit No. 9596, 9596-A, and 1975 - American River Flood Control District; second pipe installed through levee under Permit No. 9596-B, 1980 - American River Flood Control District; name change completed under Permit 9596-1 (includes work authorized under Permit No. 9596, 9596-A, and 9596-B), 2016 - City of Sacramento) [Additional Reference(s): DWR Levee Log, 2002]

Dense vegetation located on waterward slope.

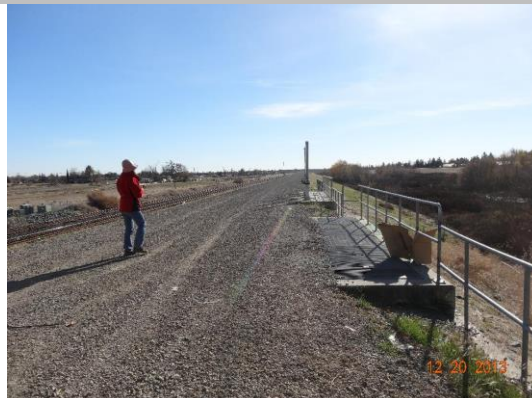
Photo 1 of 3 : UCIP_FA_2018_49863_52902.jpg

Comment Code					
Inspector Comment					
FS_ID:49863 DS_ID:24609 EP_NO: 9596 Repair Type: Non-Urgent Crossing Status: Indicator Found UCIP Comments: Dense vegetation on waterward side limits inspector's inspection--recommend removing vegetation to clear waterward slope. FIELD_STRUCT_DESC: [Sump No. 157] 2 of 3: 54-inch steel drainage pipe through the levee, 3 feet below the crown. Steel cutoff wall around pipe under center of levee. Siphon breaker in protective housing located on the waterside (WS) shoulder. Concrete headwall and flap gate located on the WS end. Trench on WS. Pumping plant located on the landside (LS). On March 28, 1995, the Sacramento City Council adopted Resolution No. 95-123 authorizing the execution of Agreement No. 95-065 regarding the transfer of drainage facilities that include Pump Station 7 as described by ARFCD and described by the City of Sacramento as Sump 157. (three 54-inch pipes installed in the siphon breaker structure but only one pipe installed through levee under Permit No. 9596, 9596-A, and 1975 - American River Flood Control District; second pipe installed through levee under Permit No. 9596-B, 1980 - American River Flood Control District; name change completed under Permit 9596-1 (includes work authorized under Permit No. 9596, 9596-A, and 9596-B), 2016 - City of Sacramento) [Additional Reference(s): DWR Levee Log, 2002] FS Date: 12/20/2013

Overview of levee crown with two concrete boxes with multiple crossings inside.

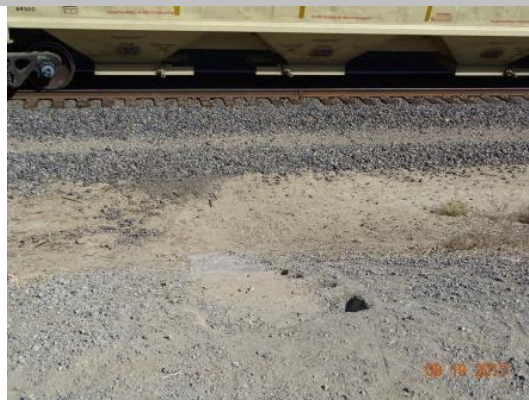
Photo 1 of 1 : FA_2018_NA0001_52_1_20180911_00001.jpg

LM Start	2.79	Rating **	M	Issue No.	1
LM End	2.79	Issue Type +	Ma	Location *	LS
Category	Earthen Levee			GPS Latitude/Longitude	
				Start	End
Item	Encroachments			38.641029°	38.641029°
				-121.471801°	-121.471801°
DWR ID	DWR_NA0001_02_f_2017_1				
Comment Code					
ST : Stairway					
Inspector Comment					
Steps dug into the levee slope.

View of the unpermitted steps in the levee.

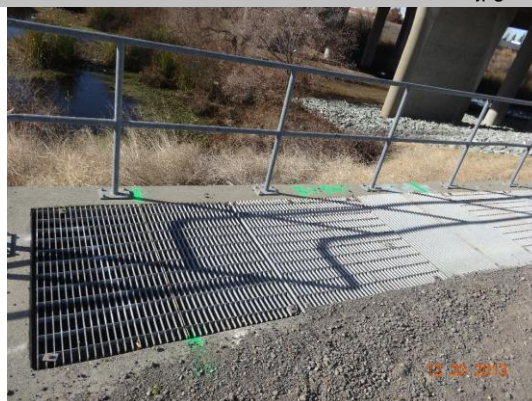
Photo 2 of 3 : UCIP_FA_2018_53492_52910.jpg

FS_ID:53492
DS_ID:24610
EP_NO: 9596-1
Repair Type: Non-Urgent
Crossing Status: Indicator Found
UCIP Comments: 07/18/2018 Pumping plant and discharge pipes appear to be the same as last time. Up and over pipe: no flooding risk. Need records from the owner. Crossing downgraded to "Non-Urgent" until we receive records from the owner, indicating that this crossing is in good condition and does not need repair. (DWR UCIP - A. McDonald)09/19/2016 LMA obtained photos of the pipes while the City of Sacramento was conducting work on the air relief valves, third pipe is a partial install unable to determine the total length of the pipe through the levee. (DWR UCIP - omagana)08/11/2016 Based on permit review for 9596, 9596-A, and 9596-B it appears that the third pipe was never installed through the levee and only the WS pipe section in the siphon breaker was installed. The section through the levee is to be installed as a future enlargement of the Pumping Plant. Need to coordinate with owner to determine how pipe is sealed through the levee. Gate missing on WS. (DWR UCIP - omagana)12/20/2013 Signs of pipe removal are visible on waterward and landward side--gate missing on WS and pump missing on LS. Need to contact owner to determine status of crossing. (DWR UCIP - omagana)

Concrete box contains 3-54 inch crossings.

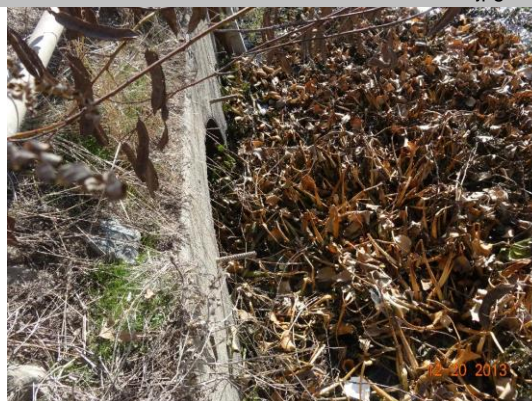
Photo 3 of 3 : UCIP_FA_2018_53492_52913.jpg

Comment Code						
Inspector Comment						
FS_ID:53492 DS_ID:24610 EP_NO: 9596-1 Repair Type: Non-Urgent Crossing Status: Indicator Found UCIP Comments: 07/18/2018 Pumping plant and discharge pipes appear to be the same as last time. Up and over pipe: no flooding risk. Need records from the owner. Crossing downgraded to "Non-Urgent" until we receive records from the owner, indicating that this crossing is in good condition and does not need repair. (DWR UCIP - A. McDonald)09/19/2016 LMA obtained photos of the pipes while the City of Sacramento was conducting work on the air relief valves, third pipe is a partial install unable to determine the total length of the pipe through the levee. (DWR UCIP - omagana)08/11/2016 Based on permit review for 9596, 9596-A, and 9596-B it appears that the third pipe was never installed through the levee and only the WS pipe section in the siphon breaker was installed. The section through the levee is to be installed as a future enlargement of the Pumping Plant. Need to coordinate with owner to determine how pipe is sealed through the levee. Gate missing on WS. (DWR UCIP - omagana)12/20/2013 Signs of pipe removal are visible on waterward and landward side--gate missing on WS and pump missing on LS. Need to contact owner to determine status of crossing. (DWR UCIP - omagana) FIELD_STRUCT_DESC: *PARTIAL INSTALL* [Sump No. 157] 3 of 3: 54-inch installed in the siphon breaker structure but not through levee. 54-inch steel drainage to be installed through the levee as part of a future expansion-no date specified as of 2016. Siphon breaker in protective housing on waterside (WS) shoulder. Concrete headwall with open WS end. Trench on WS. Pumping plant on landside (LS). On March 28, 1995, the Sacramento City Council adopted Resolution No. 95-123 authorizing the execution of Agreement No. 95-065 regarding the transfer of drainage facilities that include Pump Station 7 as described by ARFCD and described by the City of Sacramento as Sump 157. (Three 54-inch pipes installed in the siphon breaker structure but only one pipe installed through levee under Permit No. 9596, 9596-A, and 1975 - American River Flood Control District; second pipe installed through levee under Permit No. 9596-B, 1980 - American River Flood Control District; name change completed under Permit 9596-1 (includes work authorized under Permit No. 9596, 9596-A, and 9596-B), 2016 - City of Sacramento). [Additional Reference(s): DWR Levee Log, 2002]. FS Date: 7/18/2018

Gate missing for 3rd pipe on WS.

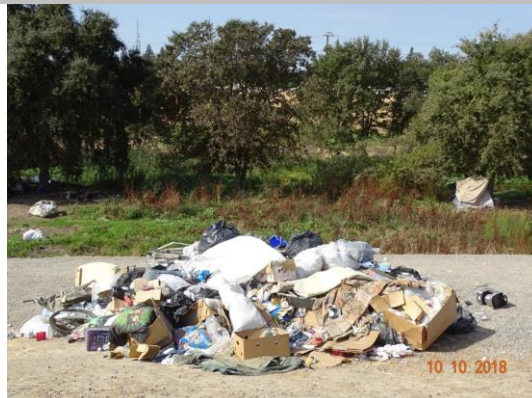
Photo 1 of 1 : FA_2018_NA0001_52_17_20181015_00042.jpg

LM Start	3.72	Rating **	U	Issue No.	17
LM End	3.72	Issue Type +	En	Location *	WS
Category	Earthen Levee			GPS Latitude/Longitude	
				Start	End
Item	Encroachments			38.654295 °	38.654295 °
				-121.474330 °	-121.474330 °
DWR ID	DWR_NA0001_02_f_2018_17				
Comment Code					
DE : Debris					
Inspector Comment					
Homeless debris on levee slope.

View of homeless debris on levee slope. Fall 2018

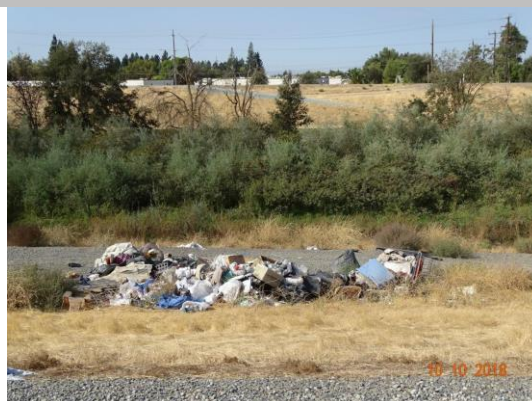
Photo 1 of 1 : FA_2018_NA0001_52_15_20181015_00041.jpg

LM Start	3.86	Rating **	U	Issue No.	15
LM End	3.86	Issue Type +	En	Location *	WS
Category	Earthen Levee			GPS Latitude/Longitude	
				Start	End
Item	Encroachments			38.656415 °	38.656415 °
				-121.474749 °	-121.474749 °
DWR ID	DWR_NA0001_02_f_2018_15				
Comment Code					
DE : Debris					
Inspector Comment					
Homeless debris on levee ramp.

View of homeless debris on levee slope. Fall 2018

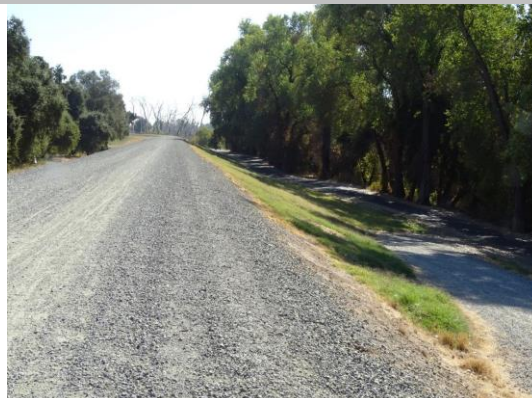
Photo 1 of 1 : FA_2018_NA0001_490_11_20181023_00029.jpg

LM Start	0.60	Rating **	A	Issue No.	11
LM End	3.46	Issue Type +	Ma	Location *	WS
Category	Earthen Levee			GPS Latitude/Longitude	
				Start	End
Item	Vegetation			38.589045 °	38.602875 °
				-121.428313 °	-121.472648 °
DWR ID	DWR_NA0001_03_f_2018_11				
Comment Code					
V1 : Control annual grass and weeds on the levee slopes and easements.					
Inspector Comment					
Annual vegetation is well maintained.

View of waterside vegetation. Fall 2018

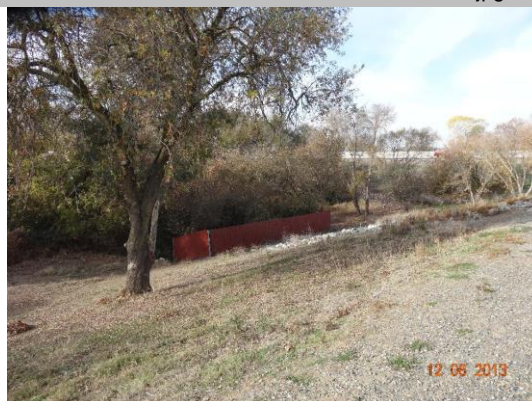
Photo 1 of 3 : UCIP_FA_2018_50047_53005.jpg

Comment Code						
Inspector Comment						
FS_ID:50047 DS_ID:24292 EP_NO: 5776 Repair Type: Non-Urgent Crossing Status: Found UCIP Comments: 8/11/2016 Issue has been addressed--no hole is present at site. Hole could have been associated with burrow activity. Need to contact owner to obtain internal integrity inspection to confirm pipe is in good condition. Crossing has been changed from Urgent to Non-Urgent due to limited evidence to support leak in pipe. (DWR UCIP - omagana)12/3/2013 Hole present next to concrete vault on levee crown (waterward side). Hole could be sink hole or burrow activity unable to determine. Need to contact owner to determine status of crossing and to investigate hole. (DWR UCIP - omagana) FIELD_STRUCT_DESC: [Drainage Plant No. 2] 5 of 6: 18-inch steel drainage pipe through the levee at an unknown depth below the crown. Metal cutoff wall around pipe under landside (LS) shoulder. Siphon breakers in concrete box located on the waterside (WS) shoulder. Pumping plant at LS toe. Access ramp to pumping plant located on LS. Concrete discharge box located on the WS. Flap gate located on the WS end. Outfall structure located on the WS. (Permit No. 5776, 1972 - American River Flood Control District; name change completed under Permit No. 5776-1, 2016 - City of Sacramento). [Additional Reference(s): DWR Levee Log, 2002]. FS Date: 8/11/2016

View of WS.

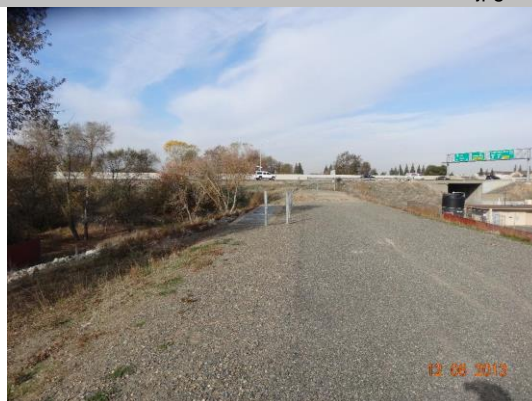
Photo 2 of 3 : UCIP_FA_2018_50047_53004.jpg

View of levee crown--concrete vault located on WS shoulder.

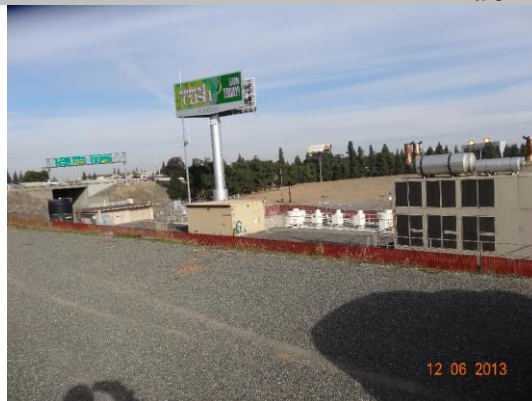
Photo 3 of 3 : UCIP_FA_2018_50047_53003.jpg

View of LS.

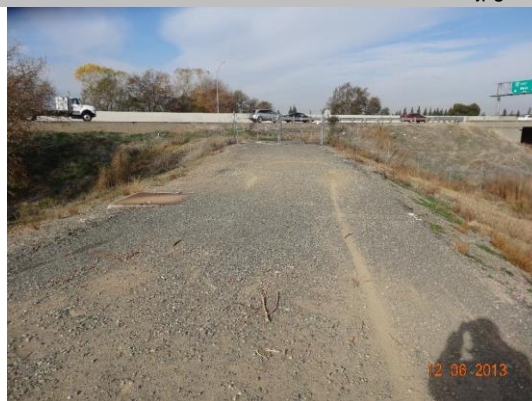
Photo 1 of 3 : UCIP_FA_2018_31224_57130.jpg

LM Start	1.54	Rating **	M	Issue No.	26	
LM End	1.54	Issue Type +	En	Location *		
Category	Supplemental			GPS Latitude/Longitude		
				Start	End	
Item	DWR UCIP Field Study			38.593290 °	38.593290 °	
				-121.443980 °	-121.443980 °	
DWR ID	24644					
Comment Code						
Inspector Comment						
FS_ID:31224 DS_ID:24644 EP_NO: 2805 Repair Type: Non-Urgent Crossing Status: Indicator Found UCIP Comments: Unable to confirm what crossings are going through levee. Will need to coordinate iwth owner to determine active crossings. FIELD_STRUCT_DESC: [Arden Treatment Plant] 3 of 4: 34-inch concrete encased sewer pipe through the levee, 7.5 feet below the crown. Concrete cutoff wall around pipe under center of levee. Siphon breaker in housing at waterside (WS) shoulder. Treatment plant on landside (LS). [Additional Reference(s): DWR Levee Log, 2002] FS Date: 12/3/2013

View of levee crown and concrete box located on waterward shoulder.

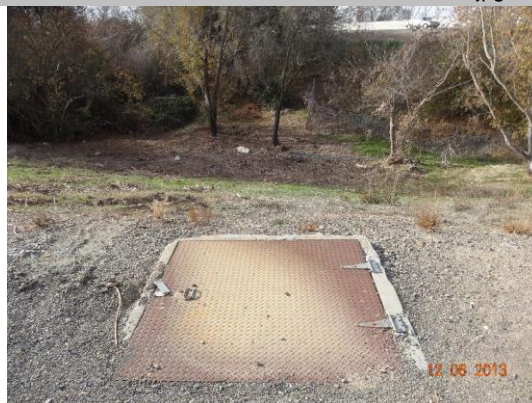
Photo 2 of 3 : UCIP_FA_2018_31224_57129.jpg

Concrete box located on waterward shoulder.

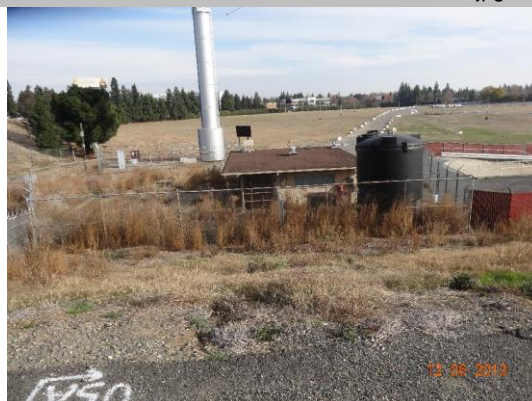
Photo 3 of 3 : UCIP_FA_2018_31224_57128.jpg

LM Start	1.54	Rating **	M	Issue No.	26 (cont)	
LM End	1.54	Issue Type +	En	Location *		
Category	Supplemental			GPS Latitude/Longitude		
				Start	End	
Item	DWR UCIP Field Study			38.593290 °	38.593290 °	
				-121.443980 °	-121.443980 °	
DWR ID	24644					
Comment Code						
Inspector Comment						
FS_ID:31224 DS_ID:24644 EP_NO: 2805 Repair Type: Non-Urgent Crossing Status: Indicator Found UCIP Comments: Unable to confirm what crossings are going through levee. Will need to coordinate iwth owner to determine active crossings. FIELD_STRUCT_DESC: [Arden Treatment Plant] 3 of 4: 34-inch concrete encased sewer pipe through the levee, 7.5 feet below the crown. Concrete cutoff wall around pipe under center of levee. Siphon breaker in housing at waterside (WS) shoulder. Treatment plant on landside (LS). [Additional Reference(s): DWR Levee Log, 2002] FS Date: 12/3/2013

View of landward side.

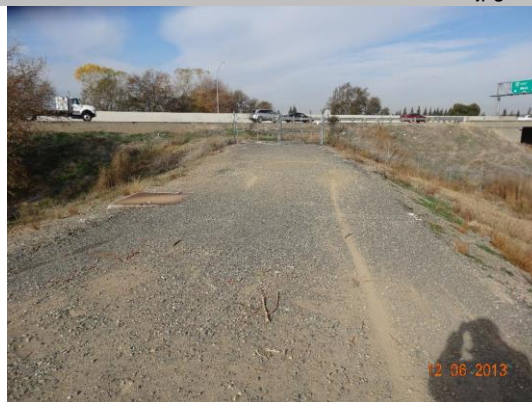
Photo 1 of 3 : UCIP_FA_2018_31225_57135.jpg

LM Start	1.54	Rating **	M	Issue No.	27
LM End	1.54	Issue Type +	En	Location *	
Category	Supplemental			GPS Latitude/Longitude	
				Start	End
Item	DWR UCIP Field Study			38.593290 °	38.593290 °
				-121.443980 °	-121.443980 °
DWR ID	24645				
Comment Code					
Inspector Comment					
FS_ID:31225 DS_ID:24645 EP_NO: 2805 Repair Type: Non-Urgent Crossing Status: Indicator Found UCIP Comments: Unable to confirm what crossings are going through levee. Will need to coordinate with owner to determine active crossings. FIELD_STRUCT_DESC: [Arden Treatment Plant] 4 of 4: 34-inch concrete encased sewer pipe through the levee, 6.2 feet below the crown. Concrete cutoff wall around pipe under center of levee. Siphon breaker in housing at waterside (WS) shoulder. Treatment plant on landside (LS). [Additional Reference(s): DWR Levee Log, 2002] FS Date: 12/3/2013

View of levee crown and concrete box located on waterward shoulder.

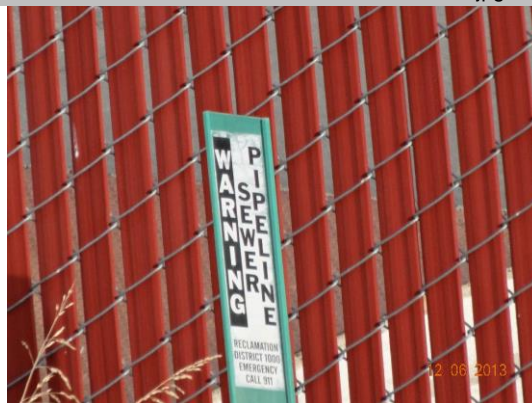
Photo 3 of 3 : UCIP_FA_2018_31225_57132.jpg

Sewer marker visible on landward toe.

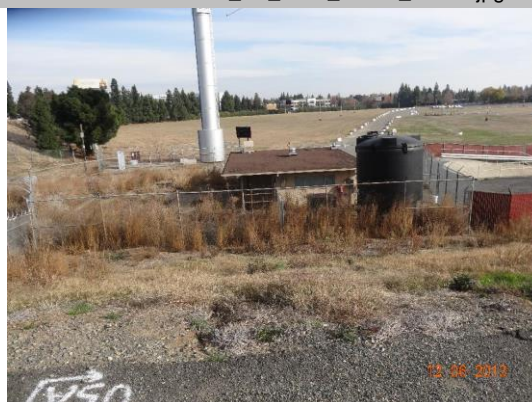
Photo 2 of 3 : UCIP_FA_2018_31227_57138.jpg

Comment Code						
Inspector Comment						
FS_ID:31227 DS_ID:24293 EP_NO: 2805 Repair Type: Non-Urgent Crossing Status: Indicator Found UCIP Comments: Will need to coordinate with the owner to determine the status of the crossings. FIELD_STRUCT_DESC: [Sacramento County Sanitation District No. 2 Pump Station] 18-inch concrete sewer main through the levee, 6 feet below the crown, 2 feet below slopes, and 4 feet along channel bottom. Concrete cutoff wall around the pipe under the center of the levee. 2-inch air release valve located on the waterside (WS) shoulder of the north levee. Treatment plant on the landside (LS). Crossing continues under the channel and through the opposite levee. (18-inch pipe authorized under Permit No. 2805, 1958 - Sacramento County Sanitation District No. 2). FS Date: 12/3/2013

View of landward side.

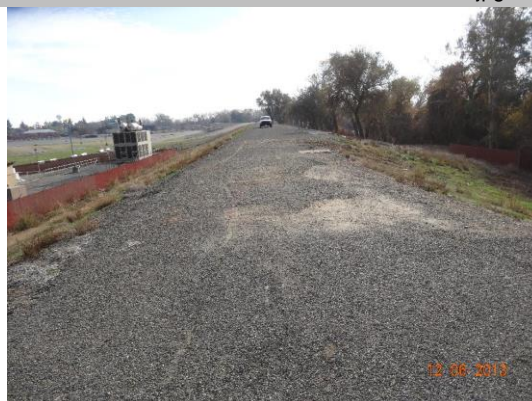
Photo 3 of 3 : UCIP_FA_2018_31227_57143.jpg

Comment Code						
Inspector Comment						
FS_ID:31227 DS_ID:24293 EP_NO: 2805 Repair Type: Non-Urgent Crossing Status: Indicator Found UCIP Comments: Will need to coordinate with the owner to determine the status of the crossings. FIELD_STRUCT_DESC: [Sacramento County Sanitation District No. 2 Pump Station] 18-inch concrete sewer main through the levee, 6 feet below the crown, 2 feet below slopes, and 4 feet along channel bottom. Concrete cutoff wall around the pipe under the center of the levee. 2-inch air release valve located on the waterside (WS) shoulder of the north levee. Treatment plant on the landside (LS). Crossing continues under the channel and through the opposite levee. (18-inch pipe authorized under Permit No. 2805, 1958 - Sacramento County Sanitation District No. 2). FS Date: 12/3/2013

View of levee crown looking upstream.

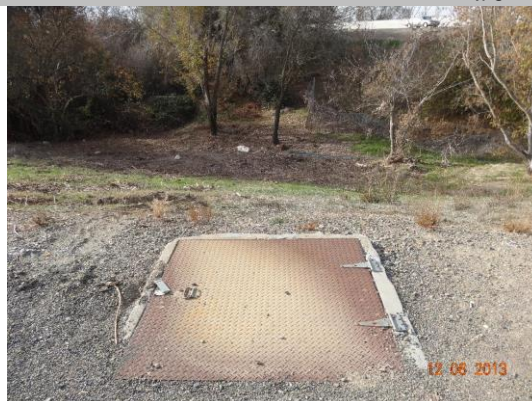
Photo 2 of 3 : UCIP_FA_2018_31223_57123.jpg

Comment Code						
Inspector Comment						
FS_ID:31223 DS_ID:24643 EP_NO: 2805 Repair Type: Non-Urgent Crossing Status: Indicator Found UCIP Comments: Unable to confirm what crossings are going through levee. Will need to coordinate iwth owner to determine active crossings. FIELD_STRUCT_DESC: [Co Sanitation District No. 2 Pump Station]: 24-inch reinforced concrete sewer main through the levee, 2.5 feet below the crown. Concrete cutoff wall around pipe under center of levee. Siphon breaker in housing at waterside (WS) shoulder. Treatment plant on landside (LS). Line connects to an existing 18-inch sewer line and 8-inch line installed under permit no. 6216. The line also connects to an existing 24-inch line located on the LS. The 24-inch line on LS parallels the levee for approximately 54 feet and ends at the pump station. (8-inch and 24-inch sewage force main fro Arden treatment plant to Elvas Freeway authorized under Permit No. 6216, 1969-Arden Sanitation District County of Sacramento, Utilities Division) FS Date: 12/3/2013

Concrete box located on waterward shoulder.

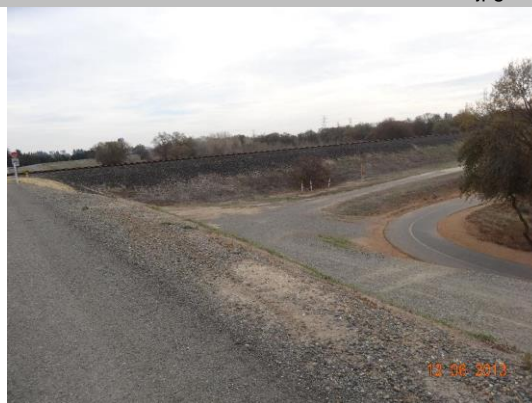
Photo 1 of 3 : UCIP_FA_2018_31230_57146.jpg

LM Start	1.91	Rating **	M	Issue No.	30
LM End	1.91	Issue Type +	En	Location *	
Category	Supplemental			GPS Latitude/Longitude	
				Start	End
Item	DWR UCIP Field Study			38.596096 °	38.596096 °
				-121.449815 °	-121.449815 °
DWR ID	24801				
Comment Code					
Inspector Comment					
FS_ID:31230 DS_ID:24801 EP_NO: N/A Repair Type: Non-Urgent Crossing Status: Found UCIP Comments: No permit found--need to contact owner to determine status of crossing. FIELD_STRUCT_DESC: Gas line through levee at unknown depth. Markers visible on waterside (WS) and landside (LS). Kinder Morgan contacts' information is 916-363-1666. FS Date: 12/6/2013

View of waterward side.

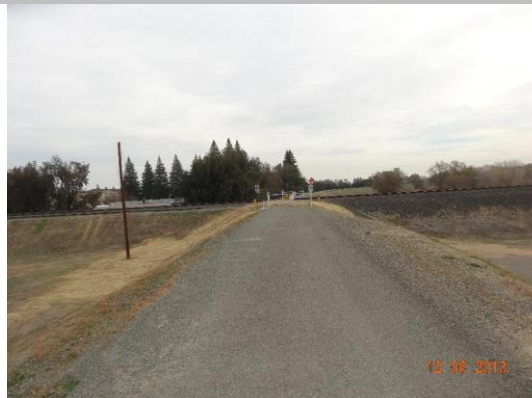
Photo 2 of 3 : UCIP_FA_2018_31230_57145.jpg

LM Start	1.91	Rating **	M	Issue No.	30 (cont)	
LM End	1.91	Issue Type +	En	Location *		
Category	Supplemental			GPS Latitude/Longitude		
				Start	End	
Item	DWR UCIP Field Study			38.596096 °	38.596096 °	
				-121.449815 °	-121.449815 °	
DWR ID	24801					
Comment Code						
Inspector Comment						
FS_ID:31230 DS_ID:24801 EP_NO: N/A Repair Type: Non-Urgent Crossing Status: Found UCIP Comments: No permit found--need to contact owner to determine status of crossing. FIELD_STRUCT_DESC: Gas line through levee at unknown depth. Markers visible on waterside (WS) and landside (LS). Kinder Morgan contacts' information is 916-363-1666. FS Date: 12/6/2013

Overview of levee crown at crossing.

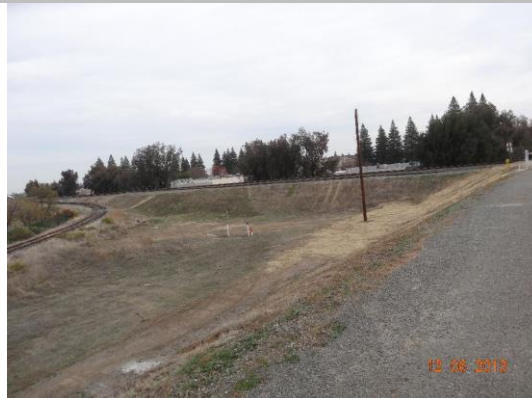
Photo 3 of 3 : UCIP_FA_2018_31230_57144.jpg

View of landward side.

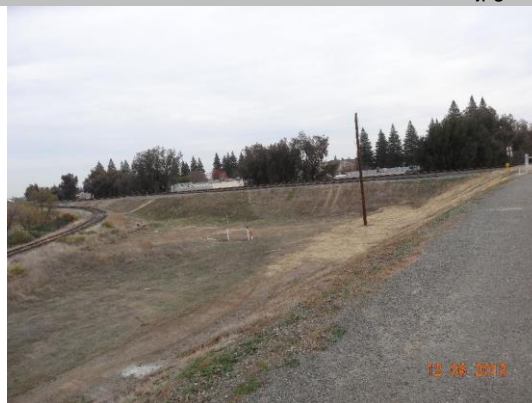
Photo 2 of 3 : UCIP_FA_2018_29826_55134.jpg

LM Start	1.91	Rating **	M	Issue No.	31
LM End	1.91	Issue Type +	En	Location *	
Category	Supplemental			GPS Latitude/Longitude	
				Start	End
Item	DWR UCIP Field Study			38.596108 °	38.596108 °
				-121.449887 °	-121.449887 °
DWR ID	24294				
Comment Code					
Inspector Comment					
FS_ID:29826					
DS_ID:24294					
EP_NO: N/A					
Repair Type: Non-Urgent					
Crossing Status: Indicator Found					
UCIP Comments: Unable to confirm the diameter size or which owner is responsible for crossing. Owner could be Quest Communication or MCI--Need to contact owner to confirm crossing and obtain encroachment permit for work.					
FIELD_STRUCT_DESC: Communications conduit through the levee at unknown depth. [Additional Reference(s): DWR Levee Log, 2002]					
FS Date: 12/6/2013

View of landward side--conduit markers visible.

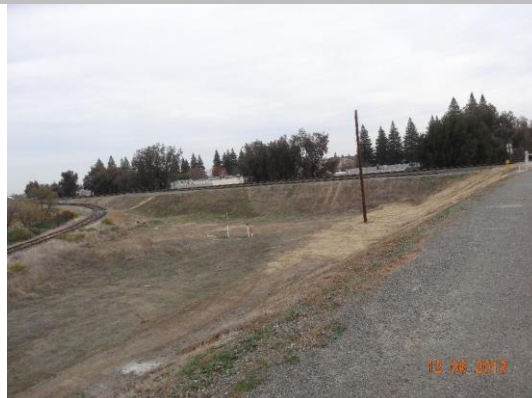
Photo 2 of 3 : UCIP_FA_2018_29827_55140.jpg

LM Start	1.92	Rating **	M	Issue No.	32 (cont)	
LM End	1.92	Issue Type +	En	Location *		
Category	Supplemental			GPS Latitude/Longitude		
				Start	End	
Item	DWR UCIP Field Study			38.596108 °	38.596108 °	
				-121.449887 °	-121.449887 °	
DWR ID	24296					
Comment Code						
Inspector Comment						
FS_ID:29827 DS_ID:24296 EP_NO: N/A Repair Type: Non-Urgent Crossing Status: Indicator Found UCIP Comments: Unable to confirm the diameter size or which owner is responsible for crossing. Owner could be Quest Communication or MCI--Need to contact owner to confirm crossing and obtain encroachment permit for work. FIELD_STRUCT_DESC: 3-inch cable through the levee, 2.5 feet below the crown. Two overhead telephone lines across the levee at location. [Additional Reference(s): DWR Levee Log, 2002] FS Date: 12/6/2013

Conduit markers visible on landward side.

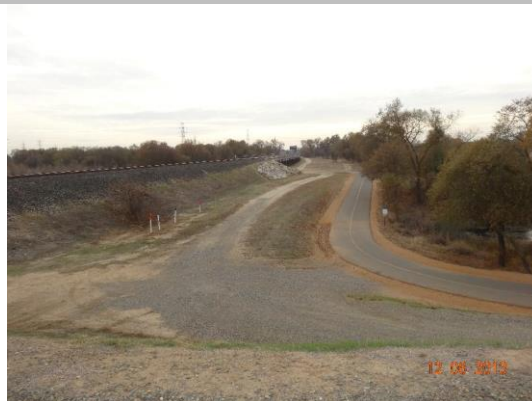
Photo 3 of 3 : UCIP_FA_2018_29827_55139.jpg

Conduit markers visible on waterward side.

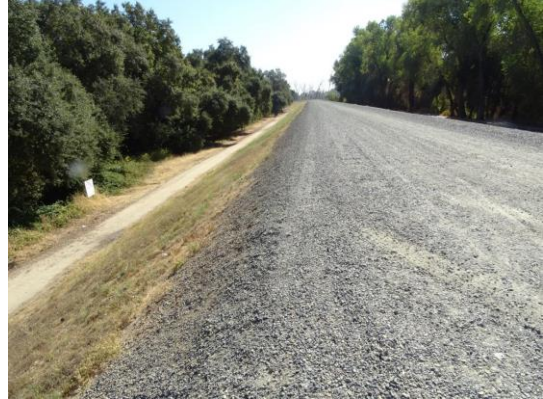
Photo 1 of 1 : FA_2018_NA0001_490_10_20181023_00030.jpg

LM Start	3.07	Rating **	A	Issue No.	10
LM End	3.07	Issue Type +	Ma	Location *	LS
Category	Earthen Levee			GPS Latitude/Longitude	
				Start	End
Item	Vegetation			38.598067 °	38.598067 °
				-121.469155 °	-121.469155 °
DWR ID	DWR_NA0001_03_f_2018_10				
Comment Code					
V1 : Control annual grass and weeds on the levee slopes and easements.					
Inspector Comment					
Annual vegetation is well maintained.

View of landside vegetation. Fall 2018
